Remove/install Multimedia Connection Unit In Front Stowage Compartment - AR82.60-P-1032NKM**MODEL 117, 156, 176, 242, 246 as of model year 2016**

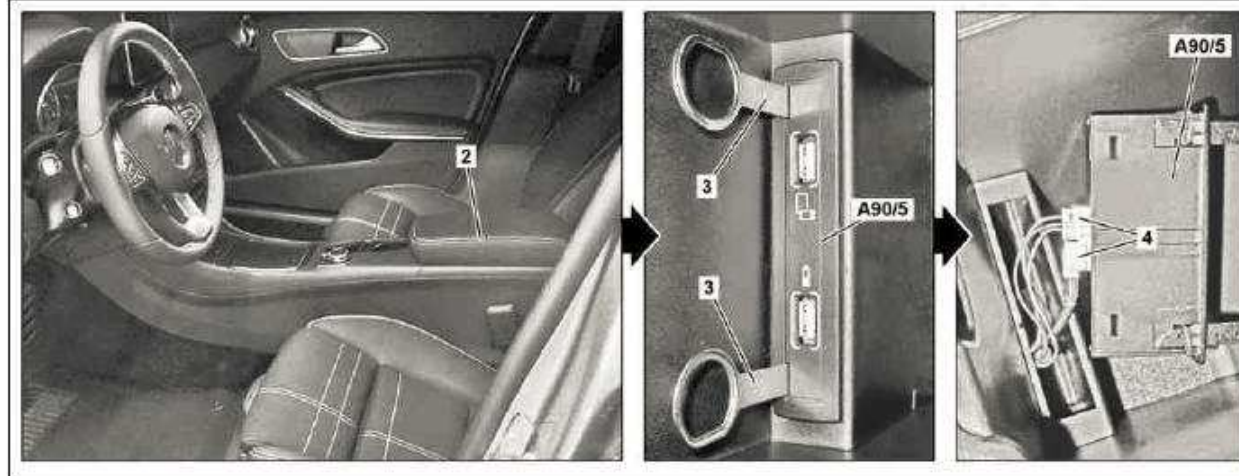
P82.60-9599-08

Fig 1: Multimedia Connection Unit In Front Stowage Compartment Remove/Install Components

A90/5 Multimedia connection unit
2 Armrest of center console

3 Removal assembly
4 Electrical connectors

Remove/install		
1	Open armrest of center console (2)

2	Insert removal fixtures (3) in openings of multimedia connection unit (1)

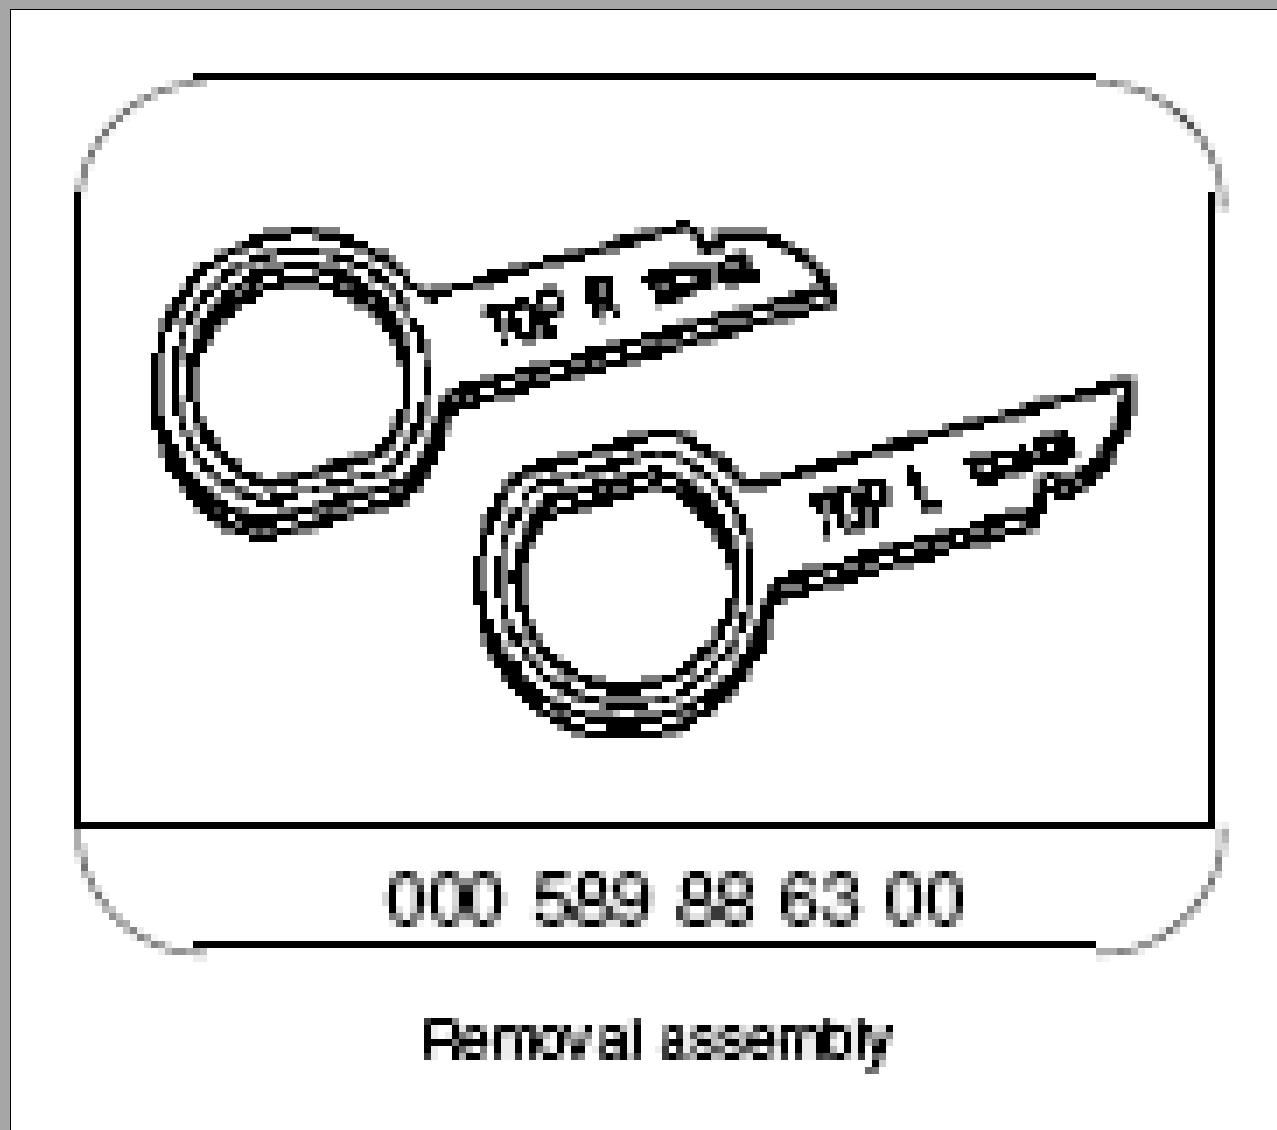
Fig 2: Removal Assembly (000 589 88 63 00)

Removal assembly	Fig 2
3	Pull multimedia connection unit (1) out of center console with lines attached

Removal assembly	Fig 2
4	Disconnect electrical connections (4)		
5	Press locks on multimedia connection unit (1) and pull removal fixtures (3) out of multimedia connection unit (1)

Removal assembly	Fig 2
6	Install in the reverse order
